Final Analysis Forensics

June 29, 2006

Reference: Smith v. Wilmington Police Department
Final Analysis Forensics Case #06-0516

Item # 1180 – 2002 Ford Crown Victoria Police Interceptor Patrol Car

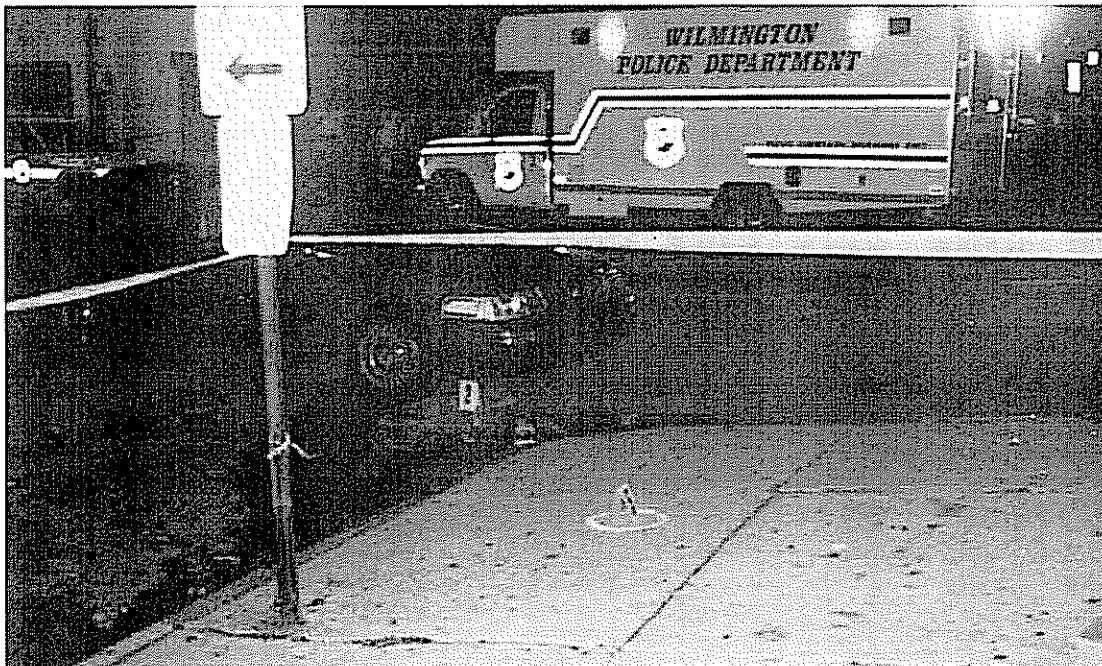
This WPD photo shows Detective Ciritella's police vehicle and its proximity to the corner. Glass fragments appear beneath the sign post in the photo's left.

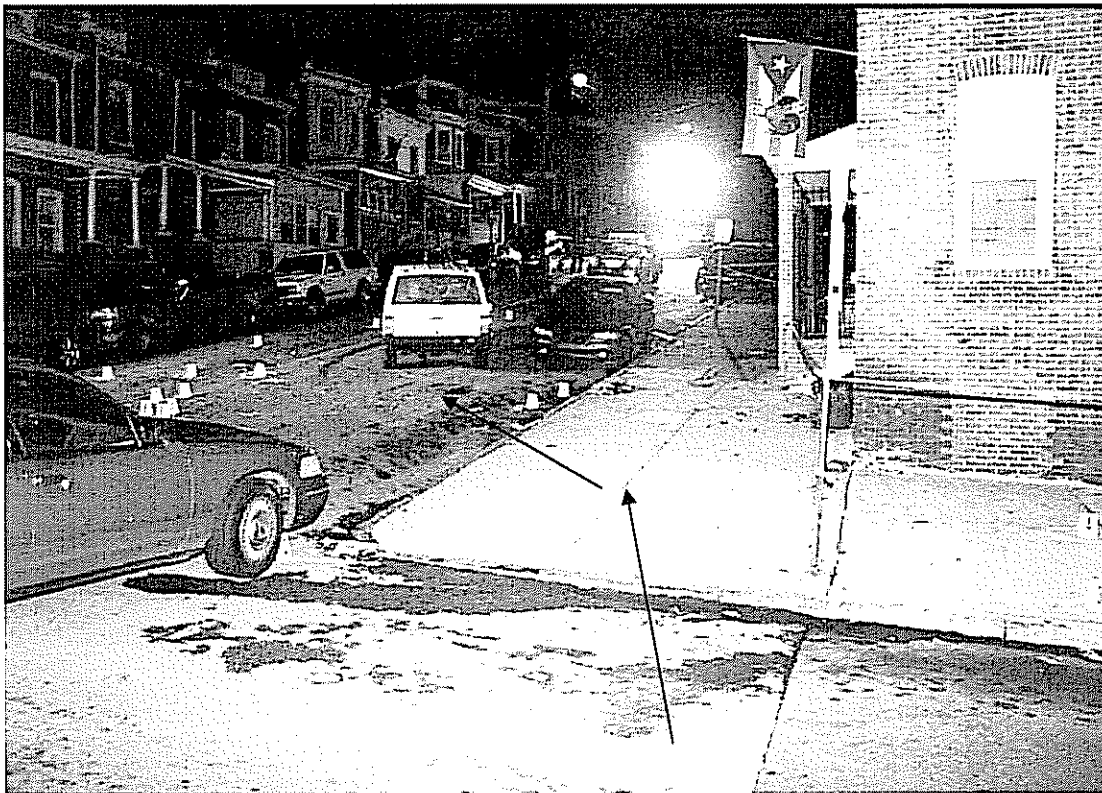
Arrows indicate general path of patrol car 1180 – there is no room for the car between Ciritella's burgundy vehicle and the corner without jumping the curb and driving on the sidewalk.

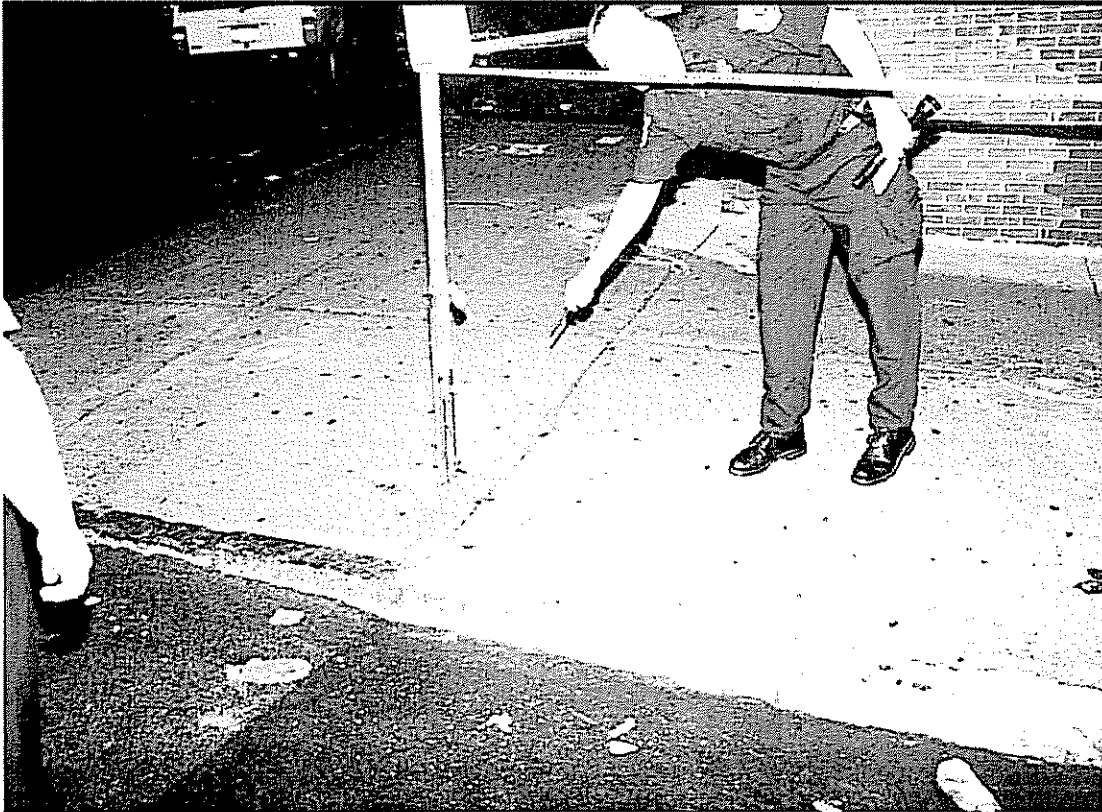
The officer is pointing to glass from patrol car 1180's tempered glass side windows which were broken by bullet impacts probably from Detective Ciritella's pistol – the patrol car would have gone directly toward Ciritella's stated position before veering left to strike the white Jeep's left front end with its right front end

The location of the glass fragments clearly places the patrol car on the sidewalk. Ejection pattern testing discussed in my report shows that the cartridge cases ejected during rapid fire would land in the vehicle no further than 98" and no closer than 6" from the pistols

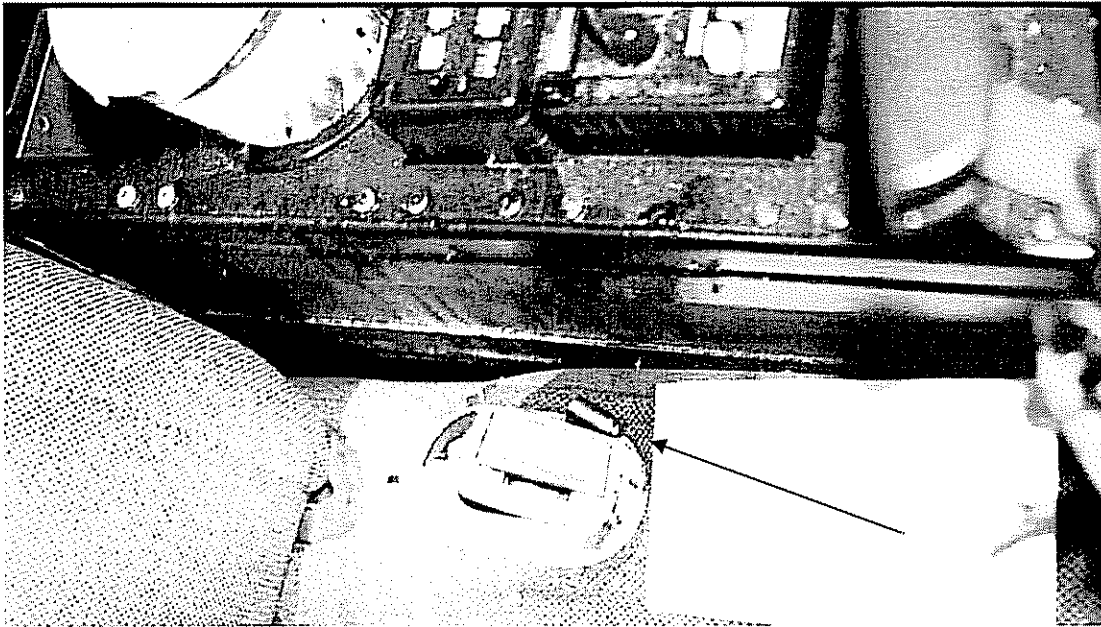
As previously discussed in my report, the tested 40 cal Smith & Wesson pistol at issue [Detective Ciritella's pistol] generally ejects spent cases backward and to the right. In order for two spent cases to land in the vehicle as noted, the cartridge cases must be in the air above the vehicle as they are traveling to the right and behind Detective Ciritella's firing position and enter the vehicle before they strike the ground [Or if, as occurred during my testing, a spent case hit Detective Ciritella and bounced off him, then they would bounce into the air very near his location (and the vehicle would be very near him indeed)].

The 40 S&W cartridge case from Detective Ciritella's pistol is indicated by the arrow. The mechanism of its deposition is discussed above.

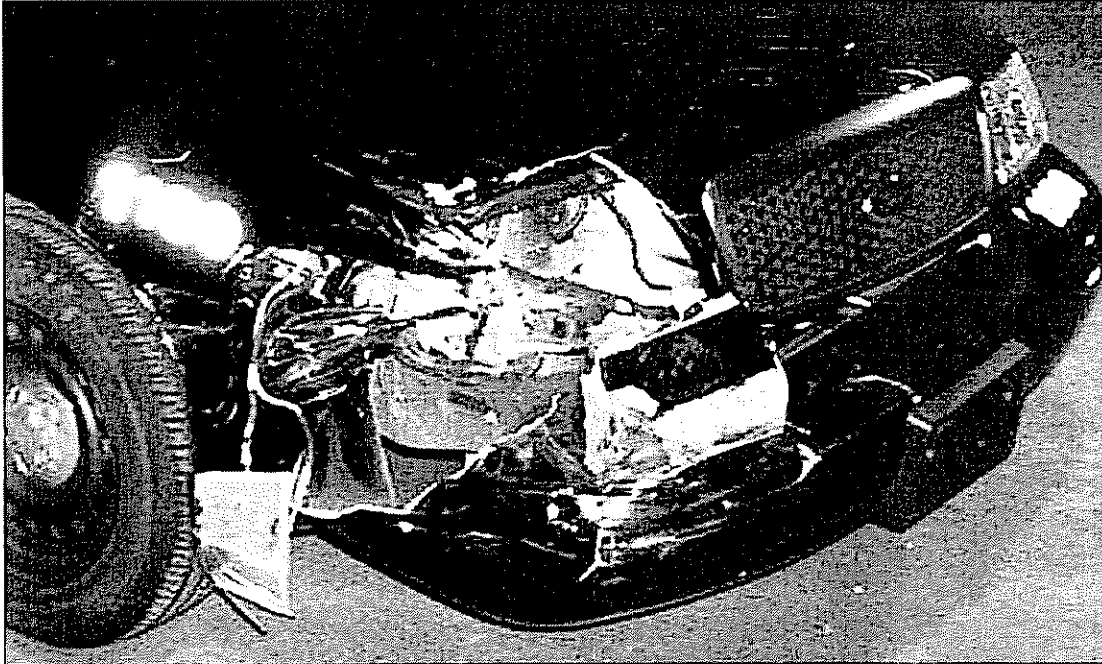
The damage to patrol car 1180 appears on the right side front. Patrol car 1180 struck the white Jeep Cherokee with its right-front fender, not with its front bumper. While striking the Jeep, the patrol car obviously did not produce an impact force sufficient to activate the airbag's switch associated with the front bumper. Crown Victoria Police Interceptors [CVPI's] airbag switches are located on the frame rails and activated by sensors on the front frame member associated with the front bumper. However, regardless of its velocity, patrol car 1180 did not strike the white Jeep in a location which would deploy the airbags. The lack of air bag deployment, therefore, is not a reliable measure of the vehicle's impact speed but instead indicates location of impact on the patrol car.

The Ford CVPI is designed with 'crumple zones' which absorb impacts in turn to prevent injury to occupants. When patrol car 1180 struck the white Jeep, it struck such a crumple zone on the right front fender (see photo below). The impact did not involve the front bumper in any manner sufficient to activate the air bags. Therefore the non-deployment

of the air bag is best explained by the fact that the impact angle with the white Jeep involved a crumple zone designed to 'give' in a crash and did not involve a force measured by the air bag sensors associated with the front bumper.

Damage to patrol car 1180 shows the effective design of the crumple zone and the lack of significant impact with the front bumper.

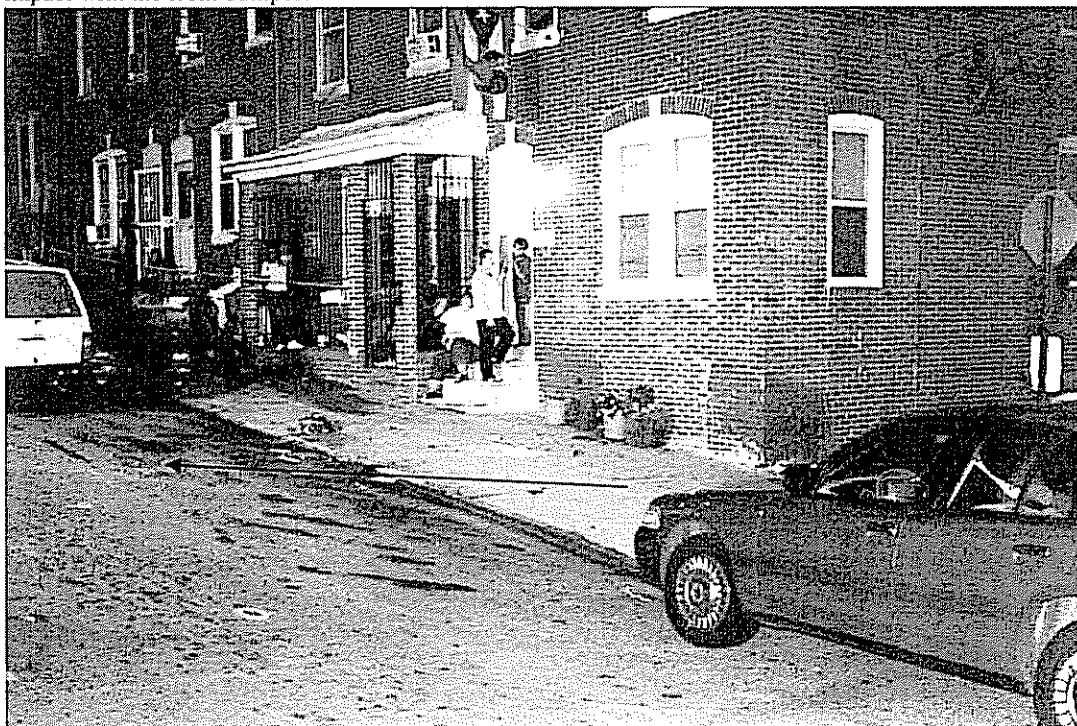
The white Jeep, originally parked facing down hill on Harrison St [a one-way street], was pushed by patrol car 1180 about 180 degrees to face up hill on Harrison St – the patrol car struck the Jeep from the sidewalk

contacting the Jeep's left front end with its right front end. The melted tire tracks left by the patrol car indicate that the vehicle was accelerating as it pushed the Jeep around (see second photo above and photo below). The arrow indicates the general path of patrol car 1180 off the sidewalk and onto Harrison St.

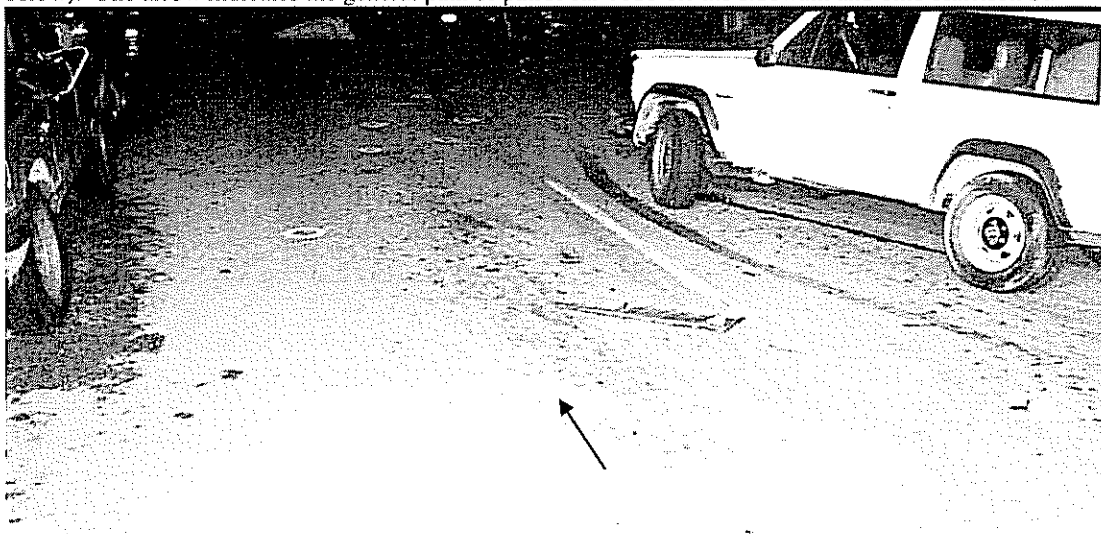
The tire marks go past the Jeep and were left by patrol car 1180's right rear drive wheel indicating that the car continued to accelerate after moving the Jeep. Tempered glass fragments from patrol car 1180's side and possibly rear windows appear in the middle of Harrison, as indicated by the arrow.

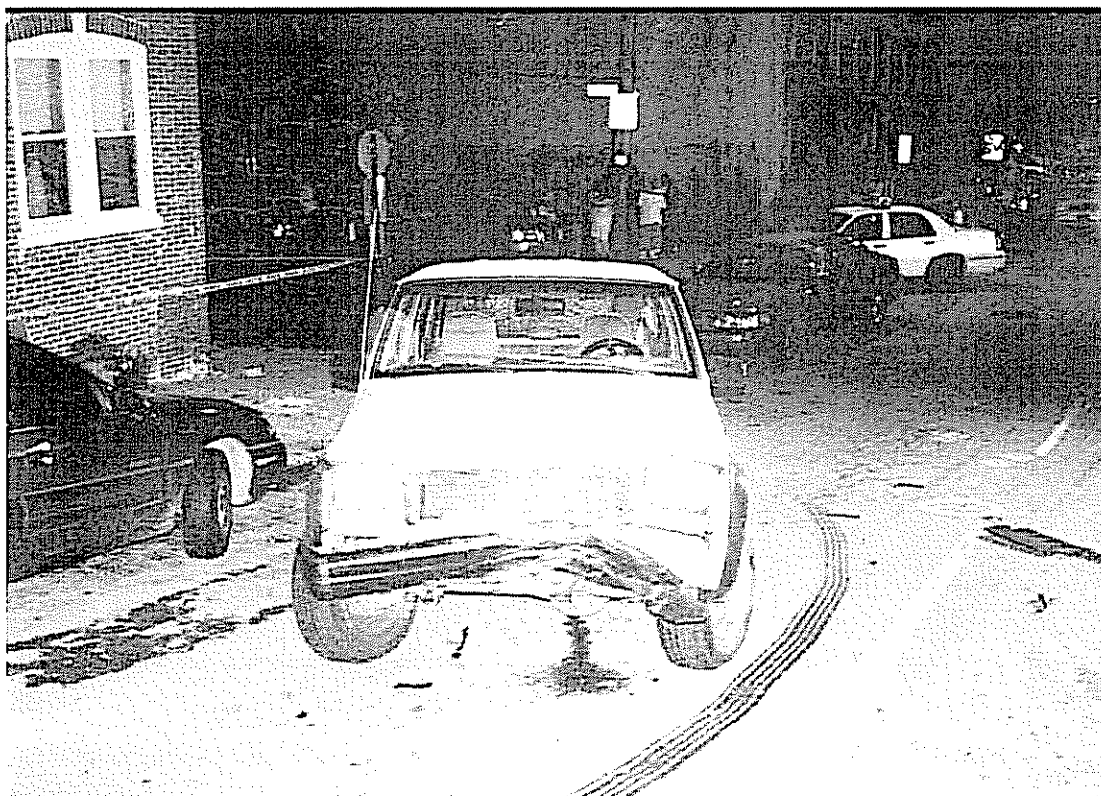
Note the tire marks from patrol car 1180's acceleration – also note the 'Club' security device which locked the steering wheel of the white Jeep into the 'tires-toward-the-curb position.'
